**Go with the flow: conservation of a floating sculpture from 1961 made from glass fibre-reinforced polyester resin**

Beerkens, L.; Stigter, S.; van Oosten, T.; van Keulen, H.

Plastics: looking at the future and learning from the past: papers from the conference held at the Victoria and Albert Museum, London, 23-25 May 2007

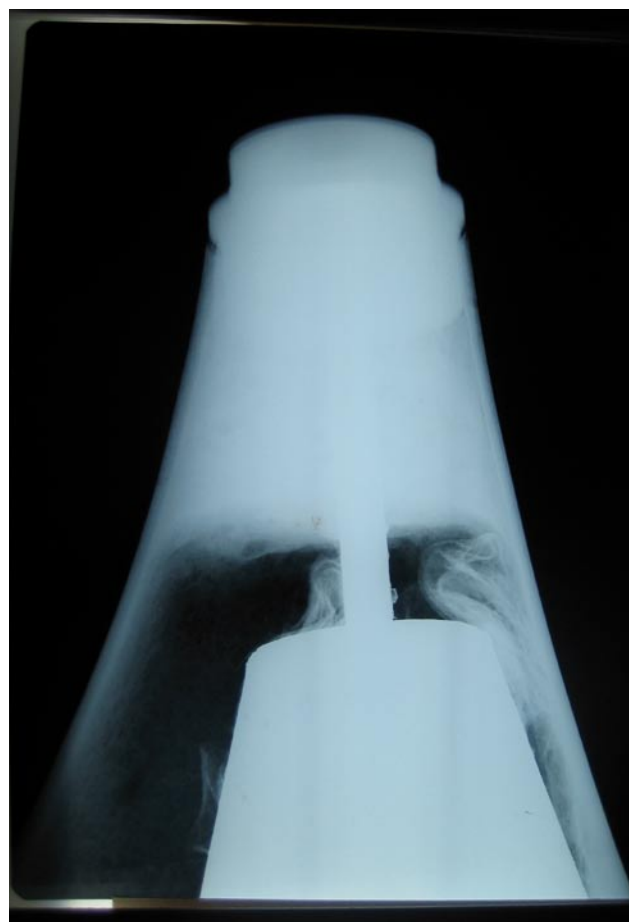
**Figure 3** Collage of the X-ray photographs of both parts of the joint in *Sculpture flottante, Otterlo* (photo: Lydia Beerkens).

To obtain a better insight into the construction of the sculpture it was subjected to X-ray examination.<sup>15</sup> A test series was made on selected areas using a mobile X-ray machine after which a continuous series of X-rays was made of the bottom edge of the hood in order to locate the added weights. Both sides of the ball joint were X-rayed, revealing the inner construction of the joint with reinforcement, counterweight and the exact vertical positioning of the joint (see Fig. 3). Radiographs of the bottom part however were unsuccessful: the lead bricks absorbed all radiation and concealed the distribution of the bricks at the bottom. Some repair patches, visible as small distortions in the surface, were revealed. Throughout the investigation, the X-ray films were reassessed from time to time; these revealed more information offering a better understanding of the production process and the material history.

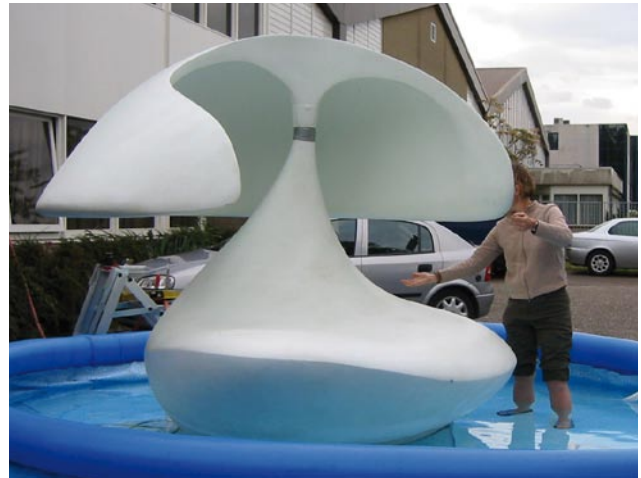
It was estimated that a weight of 37 kg on the back side of the bottom part was needed to lift the front sufficiently from the water to rebalance the sculpture in its upright position, allowing a full rotation of the hood. It is possible that some of the lead bricks had become loose during handling or transport of the object and had shifted position, thereby causing the imbalance. Adding a counterweight of 37 kg to the sculpture would cause the whole object to drop by some 2 or 3 cm in the water. This was considered to be a reasonably good solution that would not result in too much of a visible change, assuming it would be possible to add the weight.

**Figure 4** Balancing out *Sculpture flottante*, Otterlo in the inflatable basin (photo: Lydia Beerkens).

The balance of the top part was tested separately. It needed some 750 g of additional weight on the short end in order to achieve perfect horizontal alignment again. The extra weight was added by inserting a line of fishing lead weights through a small hole drilled in a disguised area in the hood. The line was fixed in the hole to allow easy removal should this be

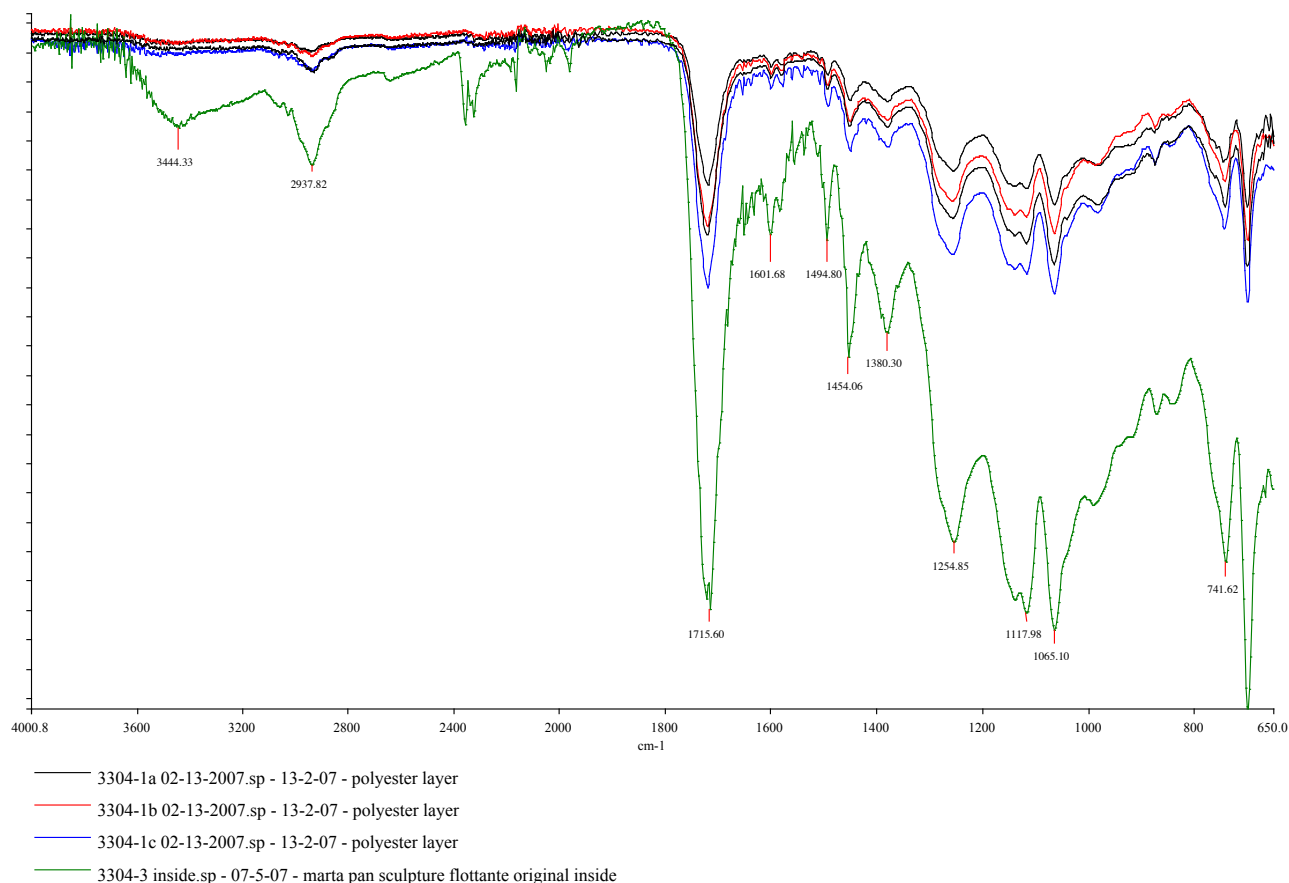
**Figure 5** FTIR spectrum of polyester layers and first white layer from Marta Pan's *Sculpture flottante, Otterlo* (green spectrum) (Thea van Oosten, ICN).

The first white layer consists of adipic acid and a polyurethane, referring to an alkyd paint (a kind of polyester resin) modified with urethane linkages. The condition of this polyester paint layer is more degraded than the other polyester resin samples, as can be seen by an increase in C–OH functional groups at  $3444\text{ cm}^{-1}$ , resulting in more oxidised and hydrolysed groups (see Fig. 5, green spectrum). The Cocoon layer consists of a polyvinyl chloride which, according to the manufacturer, is a polyvinyl chloride (PVC) polymer (see Fig. 6).

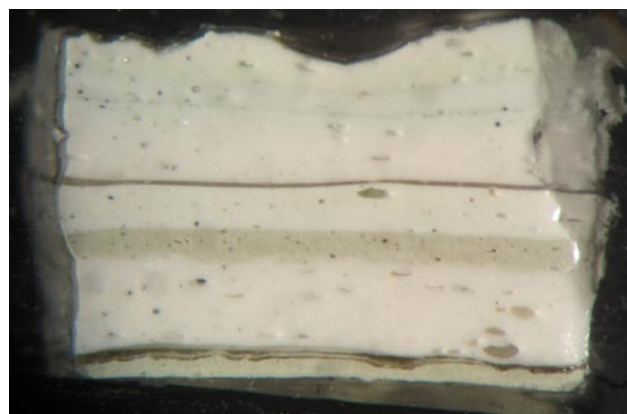
**Figure 6** Sample 1A: cross-section from the spot where a small hole was drilled for examination of the interior with the endoscope. Stereomicroscope photograph (optical magnification 64 $\times$ ) shows several layers of coating, probably seven layers of Cocoon with slightly different tones of white. The thicker layers contain numerous air pockets (sample preparation and photo: Evelyne Snijders, SRAL).

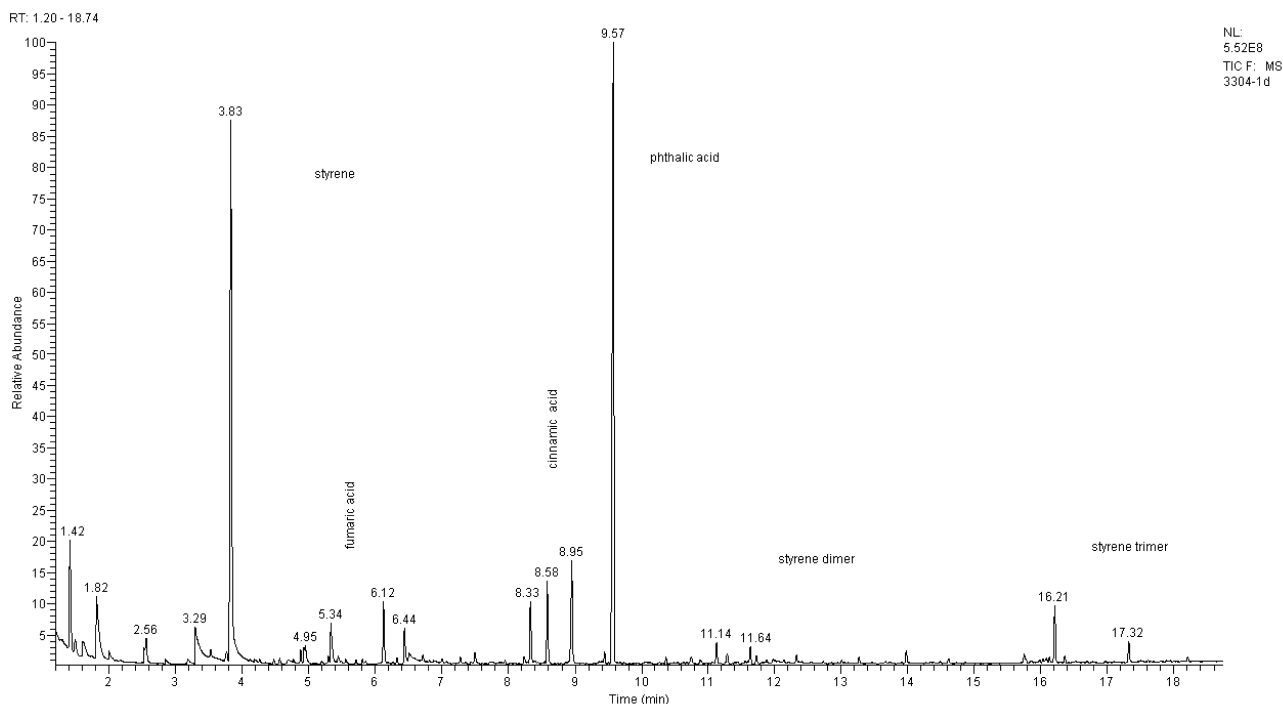
**Figure 7** GC–MS spectrum of the glass fibre-reinforced polyester.

According to Py-GC–MS, the components or ‘building blocks’ of the polyester samples of the inside of *Sculpture flottante, Otterlo* are all similar and consist of fumaric acid, ethylene glycol and o-phthalic acid.<sup>17</sup> The presence and peak height of fumaric acid, cinnamic acid and styrene dimer and trimer confirm that the GRP sample is in good condition (Fig. 7). No serious amount of degradation was established on the polyester samples due to the fact that the polyester was protected by the various Cocoon layers.
