LECTURE 015 MATTI SUURONEN'S 'FUTURO' - PROTOTYPE, 1968 BACK IN BUSINESS IN THE 21TH CENTURY

BY LYDIA BEERKENS, SAMI SUPPLY, TIM BECHTHOLD

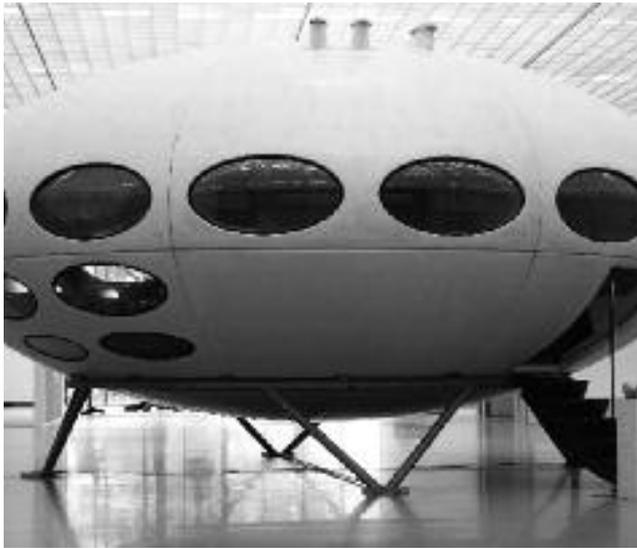
Figure 1
Futuro Prototype
 Overview 2011 after conservation
 Photo: Nikki van Basten
 See colour plate, p. 184

The assembly in 2011 showed the good final result of the conservation treatment; the oval shapes with the repetitive black lines of the oval windows and the smooth bluish polyester surface emphasize its characteristics again. The *Futuro* Prototype has regained its strong design features of futuristic design and modern life style and was welcomed back by its architect Matti Suuronen at the opening of the exhibition in the museum in May 2011.

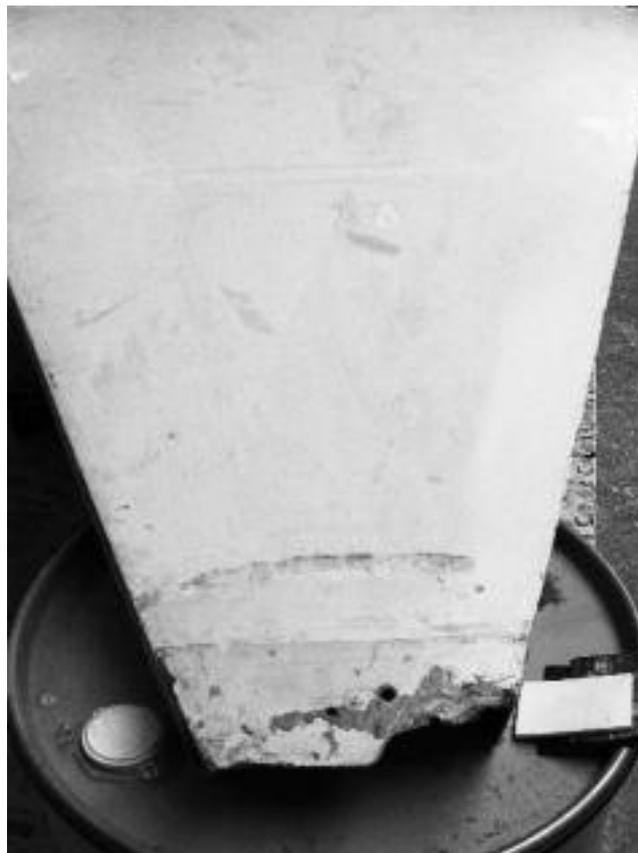
Figure 4
Detail of one of the shell elements;
halfway the surface cleaning treatment

During the cleaning of the outer shell a remarkable shift in colours showed up. (see Figures 4, 5) The gelcoat colours are not monochrome blue anymore but seem to have faded partially due to sunlight exposure. Another possible reason for the patchy appearance could be the working method in production. Maybe the colors for the gelcoat were not well mixed in the first place, in some areas one can clearly recognize large brushstrokes deriving from the application of the gelcoat mixture in the mould. The overall multicoloured shades, which vary from blue to purplish beige and green grey, are not visible on the few remaining early photographs. How this process was instigated is still subject of research.

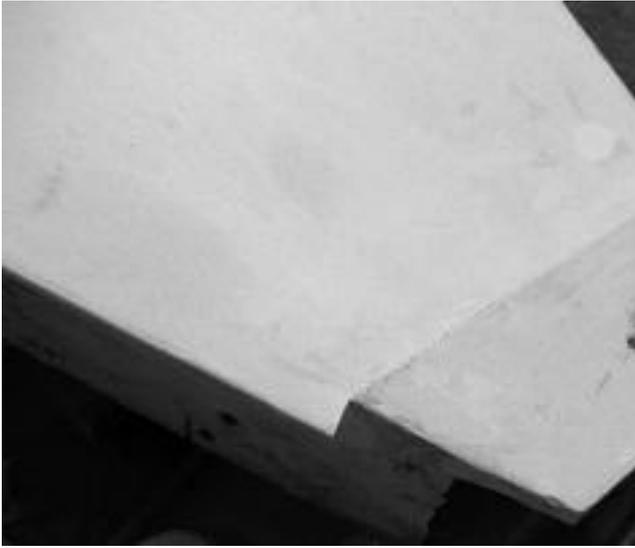
Figure 5
Detail of the same element
during the cleaning process

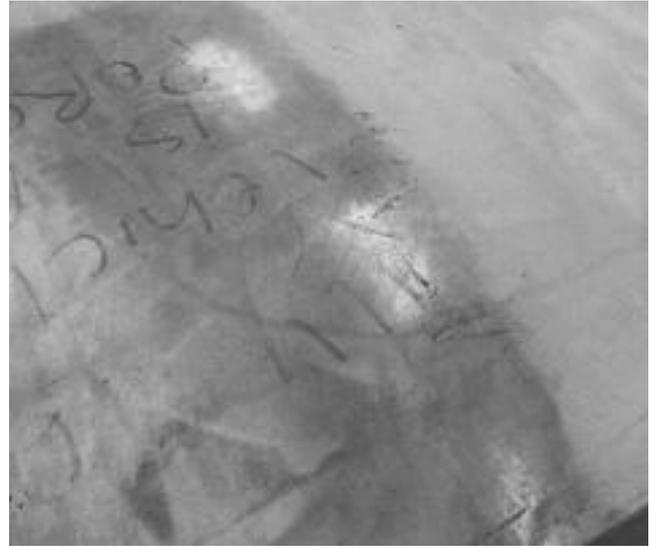
Figure 6
Detail of the damaged top end
of one of the shell elements

The cooperation with the Poly Products company provided in the know-how of repair and treatment of aged fiberglass reinforced polyester objects. The conservation treatment was carried out by Poly Products employees in one of their factory halls, accommodated with a lifting hoist, enabling easier handling during the assembly. The treatment existed in a lot of cleaning and slight polishing, filling larger lacunae and old drill holes with the appropriate filler materials, mixed in matching colours, used in the polyester industry (see Figures 6, 7). This made it possible to execute

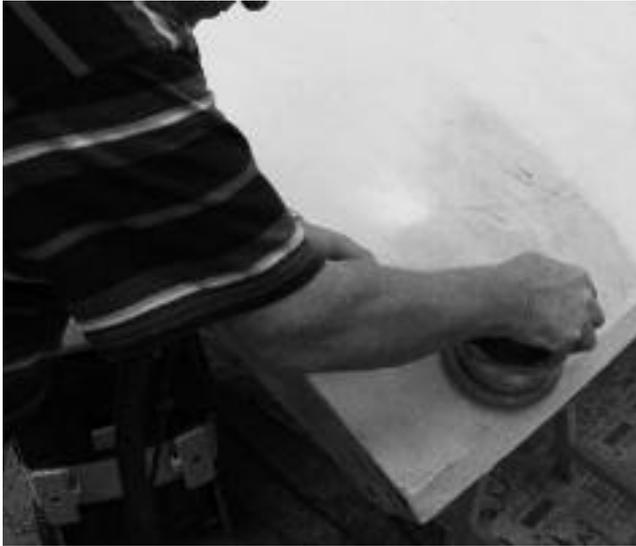
Figure 7
Detail of the same element
after repair of the loss

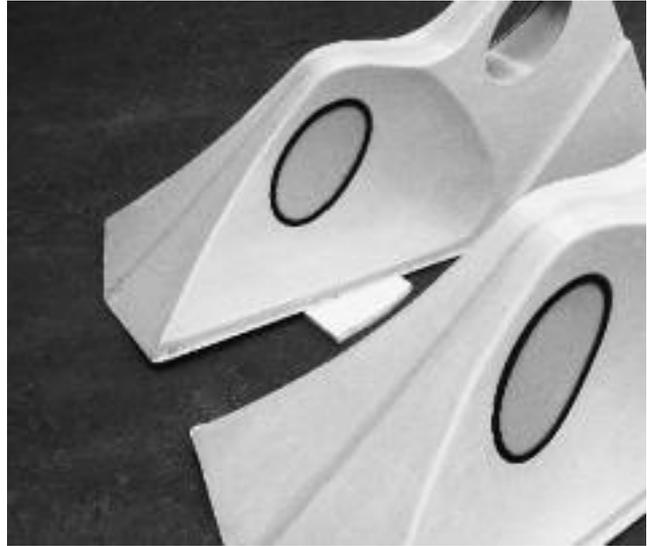
The blue polyester interior was in much better condition than the outside although a similar but less pronounced shifting of the blue colour can be detected here as well. (see Figure 8) Some polyester interior elements are still fully blue, in particular the

Figure 8
Two fiberglass reinforced polyester elements
from the seats in the living room

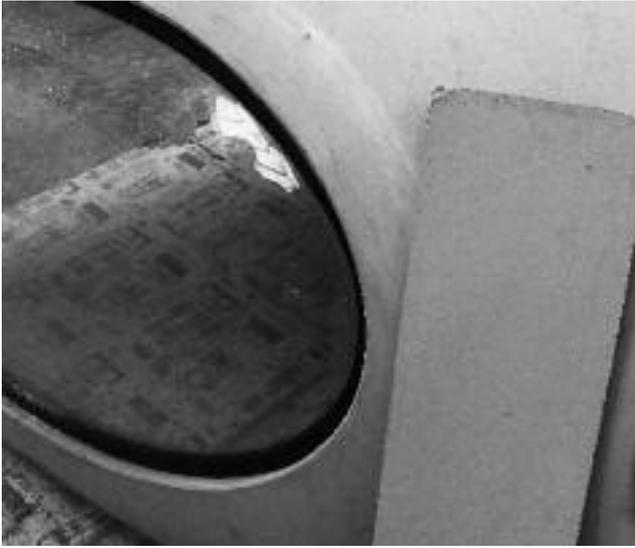
complete bathroom where sunlight hardly enters and the polyester hasn't suffered from light exposure (see Figure 9). Very disturbing in the interior were the darkened retouches, everywhere on the purple walls and the ridges covering the bolted connections between the shell elements. The surface here, with its typical fiberglass surface structure of the 'lay-up' method, was painted with matt acrylic house paint. It was decided to repaint the complete inner walls and all purple elements rather than painstakingly try to remove retouching, as there was no aesthetic or artistic input in this painted surface other than its mere colour.¹³

Figure 9
Detail with a small shelf from the interior,
still bright blue, in front of the faded blue shell element

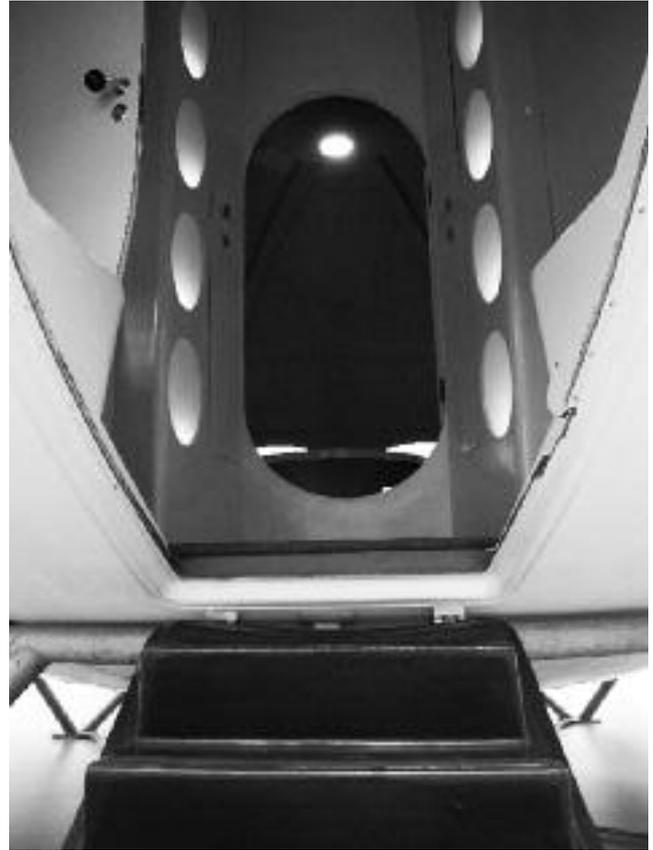
The partial delamination of the insulation foam from the inner and outer polyester layers of the shell elements as a result of handling stress and storage under tension in ever changing positions has weakened the elements and may cause eventually more cracks in the polyester. The door, being the stairs to the interior at the same time, also showed this delamination inside, making the stairs less strong.

Figure 10
Futuro Prototype.
View of the entrance in 2011 after conservation.
Photo: Nikki van Basten

a good and solid restoration within a reasonable time and feasible budget. The door element with its entrance stairs was cut open to reinforce the steps from the inside with extra plywood and polyester and was then closed again (see Figure 10). By refraining from future exhibition outdoors for the benefit of preserving the original, the treatment could be limited to cleaning, do local repairs and small reconstructions and strengthen the constructive components.
